POOL CONCOURSE ***GUIDELINES***

DESIGN
CONSTRUCTION
MANAGEMENT
MAINTENANCE
CONSIDERATIONS

JULY 2011

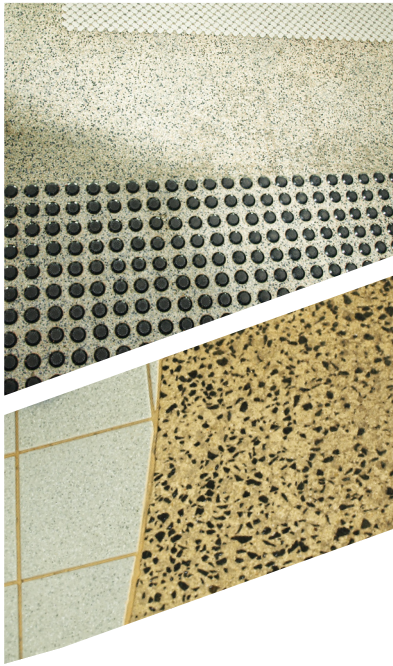
Multiple surface and slip resistance change from tactile sensors / applied surface to rubber matting

Surface and slip resistance change from pool deck shower tile to machined concrete

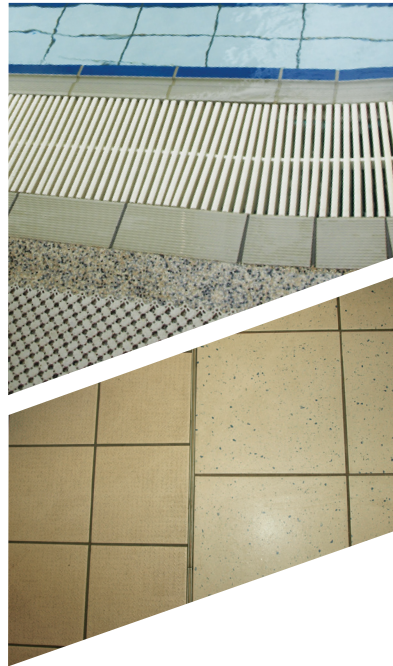
Surface and slip resistance change from matting / applied surface / tile / grating

Mixed tile slip resistance from non slip to polished surface

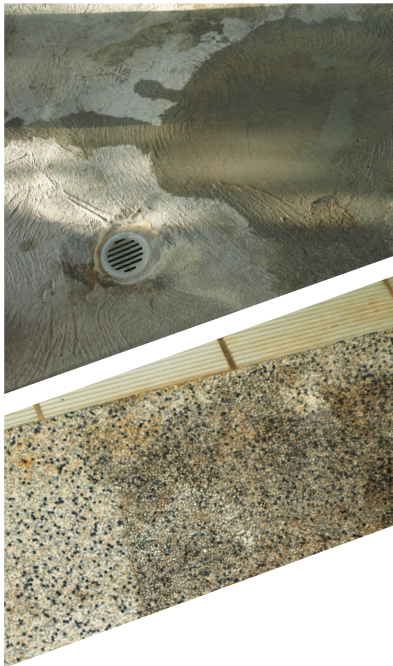
Incorrect broomed concrete surface grading and subsequent water ponding

Incorrect gradient, water seepage under concourse seal, resulting in mould and rust build up

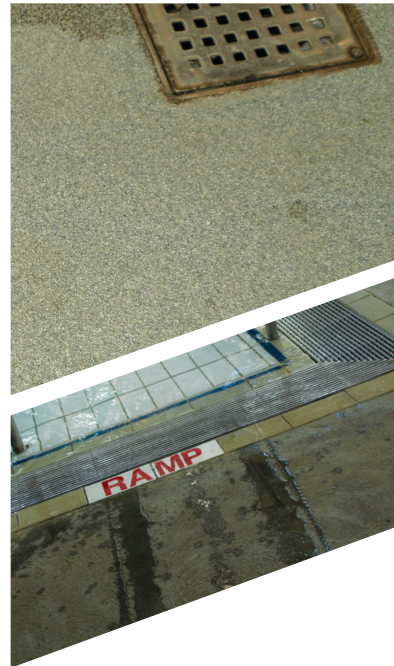
rusting drainage grate

water tracked by wheelchairs

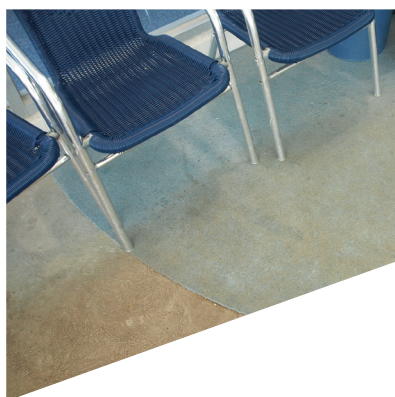
Varying cleaning requirements – dirt and grime build up on broomed concrete adjacent to applied finish, compared to low use area under seating

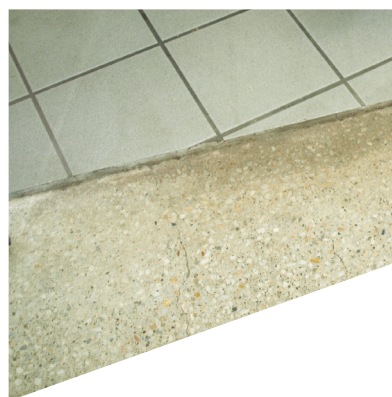
Alternate surface cleaning requirements for polished concrete and adjacent non-slip tile

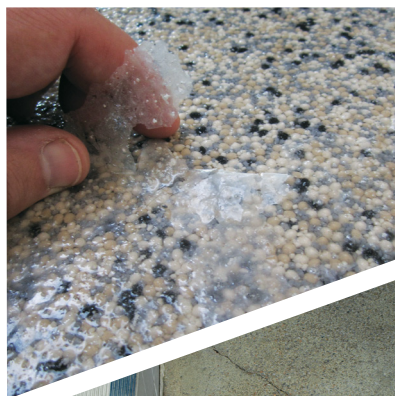
De-lamination of sealer over applied concourse material

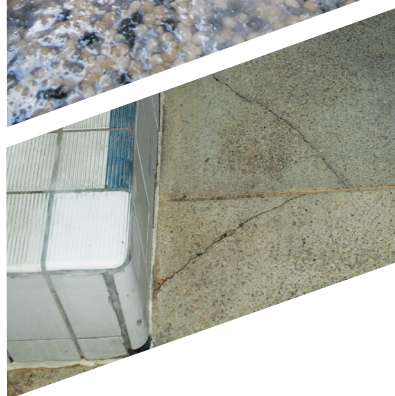
Reflection cracking in concourse affected by steel reinforcement design and concourse slab tensions

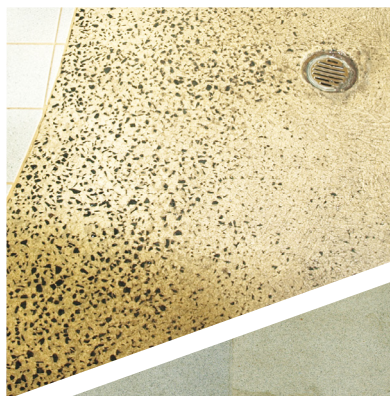
Grinding of concrete to rectify incorrect finished floor levels between pool deck shower tile and broomed concrete concourse

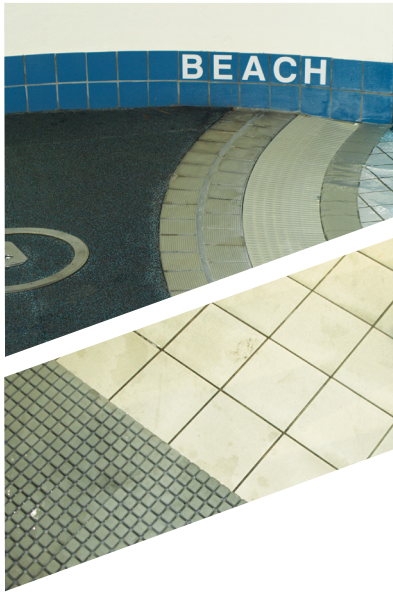
Varying cleaning regimes required to manage grime, dirt and calcium build up on concourse tile and rubberised surface, grouting and wall tiles

Additional management of cleaning under rubber mats over tile around pool concourse

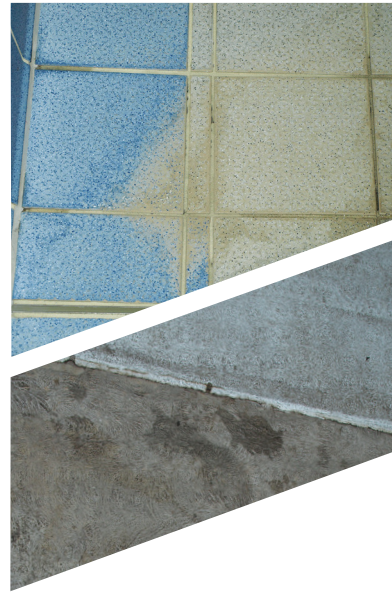
Cleaning effects on coloured non-slip tile

Variation in cleaning effects on broomed concrete to remove dirt, grime and body fats build up – varying quality of expansion joint sealing/caulking
